## Test Report

**Report No.:** THSH24032056042EN

Sample Name : Iron sheet with Multiface adhesive coating

Sample Model : Multiface adhesive

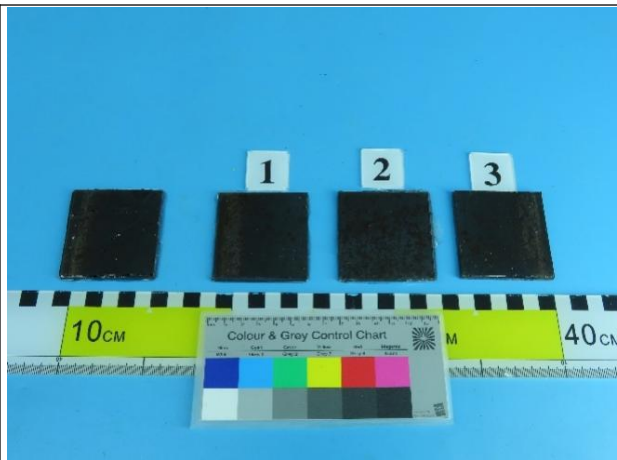
| Test Item | Result | Client's requirement | Conclusion |
|---|---|---|---|
| Heat Ageing Test | Visual discoloration, but the glue has no visual peeling or cracking | The glue has no peeling or cracking | Pass |

| <p>Reference Sample                      Test Sample</p> <p>Before Test-Sample A</p> | | <p>Reference Sample                      Test Sample</p> <p>After Test-Sample A</p> | |

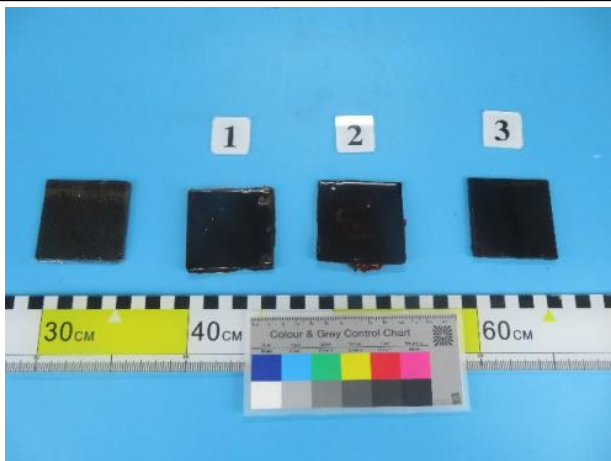
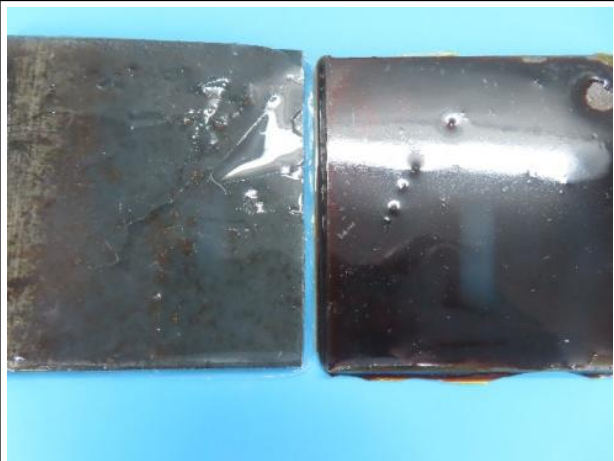
| Test Item | Result | Client's requirement | Conclusion |
|---|---|---|---|
| Temperature and Humidity Test | Visual discoloration, but the glue has no visual peeling or cracking | The glue has no peeling or cracking | Pass |

| Reference Sample | Test Sample | Reference Sample | Test Sample |
| After Test-Sample A | | After Test-Local Part-Sample A | |
